NEBRASKA HISTORIC BUILDING SURVEY

FINAL REPORT AND PRELIMINARY INVENTORY

HARLAN AND FRANKLIN COUNTIES

RECONNAISSANCE SURVEY

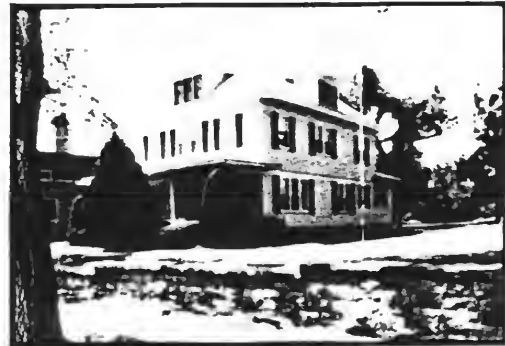
HNO4-3

The Immaculate Conception Church complex is composed of three visually and functionally dissimilar buildings. Within the boundaries of this site are a two-story frame parsonage.....a two-story brick school.....and an exceptionally well preserved stone church. While all three structures contribute to the importance of the site, it is the church which displays the greatest architectural significance. It is rectangular in plan with a corner tower and a subtle transept placed between the nave and chancel. A bold image is created by using large rusticated stone block walls supported by corner and side buttresses also made of stone. Single lancet windows pierce the thick walls along the first floor level with a round tracer window centrally located in the front gable. The entry is emphasized with a gabled stone portal which projects out from the center and is decorated with corner buttresses and grouped half columns supporting a pointed arch.

- ☐ Construction materials. The comparatively unique use of large rusticated stone blocks. Excellence of craftsmanship
- ☐ Significance as a religious/educational complex:
 - Physically- one square block consisting of four structures.
church, school, parsonage and garage.
 - Culturally- The church represents a religious/educational philosophy of a specific community.
- ☐ Integrity. After numerous years of existence, the church remains in excellent condition.

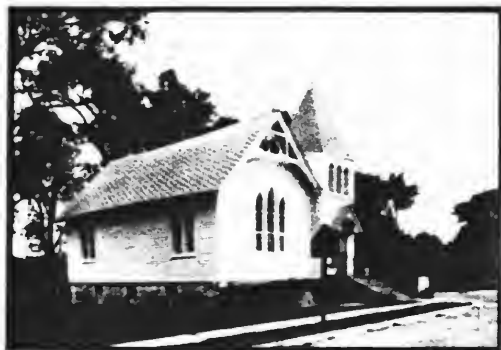
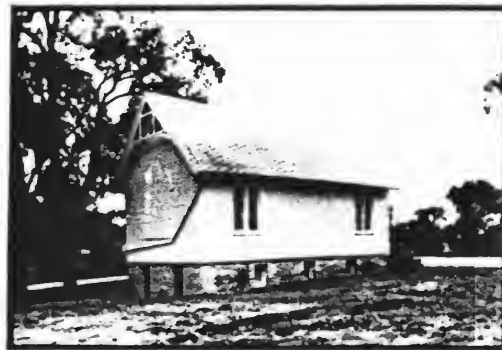
FRO7-7

The Riverton Congregational Church. Built in 1885, this church consists of a frame, rectangular structure with corner tower which functions as the entry and houses the church bell. The tower has a hip roof. Gothic windows and a limestone foundation also appear.

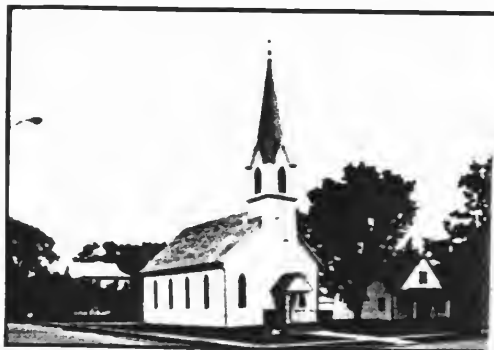
FRO2-28

Trinity Lutheran is a small, frame, rectangular church. The front facade consists of a centralized steeple and centralized entry with one narrow gothic window on each side. Four equally spaced gothic windows stretch on both sides of the church. The parsonage is located adjacent to the church. Description for the parsonage is rectangular, one unit, one story, gabled roof and latitudinal/P:Fca=: S:H. Both structures have wood shingles on their roofs and both are in very good condition and are still in use.

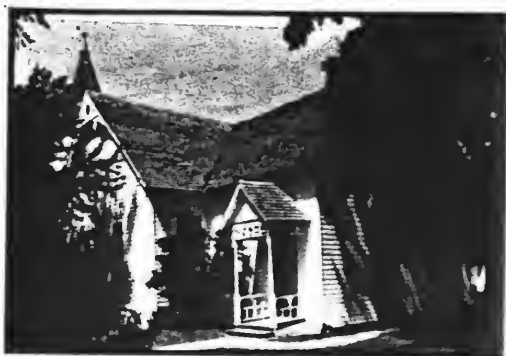
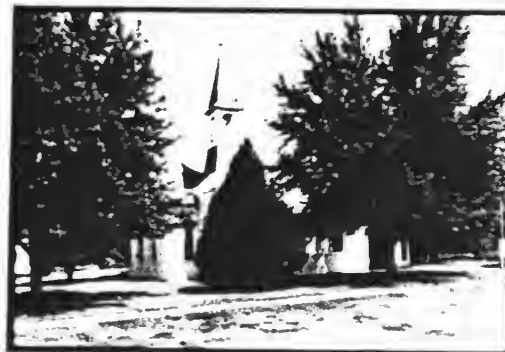
HNO4-39

Built in 1885, the Orleans Evangelical Church consists of an unusual "T" shaped plan with an engaged corner bell tower that also functions as the main entry. A secondary entrance is found on the south end of the west facade. The church is built of wood frame construction with gable roofs sheltering the "T" of the plan and a pyramidal roof capping the tower. It is placed in a latitudinal orientation on its site and presents a gabled end detailed with decorative bargeboards. Additional decoration is found in the eastlake detailing of the small porch covering the secondary entrance

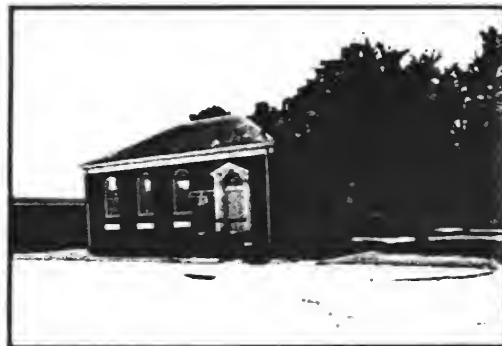
FRO3-46

Franklin Public Library. Raised one story rectangular library made from red brick. This building has a hipped roof with offset chimney. Orientation is latitudinal. The front facade consists of three Georgian windows and an end entry. The entry is emphasized by wooden pilasters and triangular portico with an arched transom. Condition of this site is very good and it is still in use as the public library of Franklin.

- ⌘ Application of architectural style, i.e. Georgian characteristics.
- ⌘ Contributes to the limited but exceptional group of public libraries found in the study area.
- ⌘ Extant resource of a rare function within the study area.
- ⌘ Integrity. Structure remains in unaltered condition.

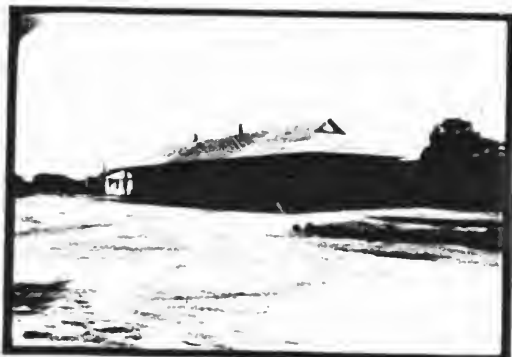
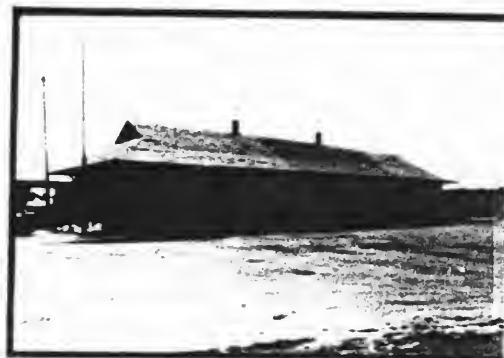
HNO4-2

The Orleans depot, despite abandonment, is fortunate enough to have retained both its original condition and location. The structure echo's the form and image associated with other buildings from its typology. It consists of a long rectangular plan and is built using a wood frame construction. It is sheltered by a gabled roof with curved eave brackets. Double chimney's pierce the roof at the central ridge of the roof.

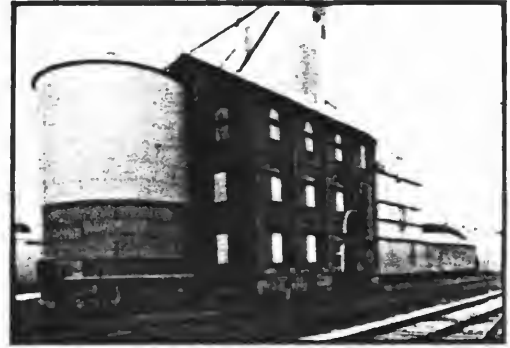
FRO2-20

A three story brick mill with gable roof and arched brick lintels, corner pilasters as well as three wall pilasters. Pattern: corner pilaster, window, pilaster, window, pilaster, window, pilaster, window, corner pilaster. The mill is situated on the railroad line and is in poor condition. Windows have been boarded and grain elevators now ajoin and interupt the mills structure as well as its clarity.

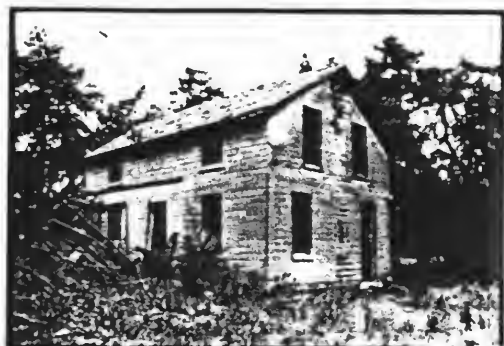
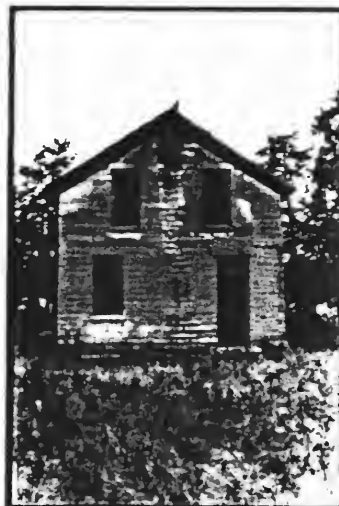
FROO-68

Quartzite rock house. This uncommon house is rectangular in plan, has a gable roof and is orientated longitudinal. The house has narrow vertical windows with stone lintels. Two chimneys once appeared on each end of the house but the house has been abandon and is fast deteriorating. A frame porch once stood on the side of the house and had two entrances into the house. A rock cellar is nearby and is in poor condition. The inside framework of the house has been removed. The quartzite is in good condition though.

- ✦ Highly significant representative of rural vernacular building.
- ✦ Major contribution to identified theme: Quartzite Rock Houses of Franklin County.
- ✦ Architectural significance based on material use and excellence of craftsmanship.
- ✦ Integrity. Despite being abandoned, the house retains its vernacular characteristics.

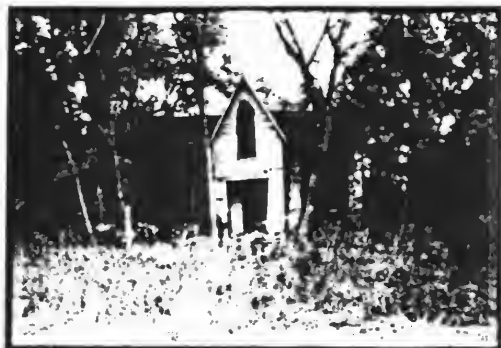
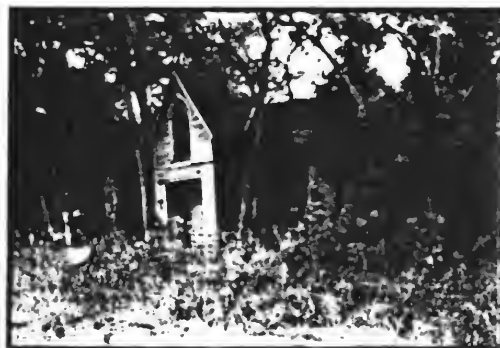
FROO-6

This is a limestone house, rectangular, $1\frac{1}{2}$ stories, gable roof with centralized front facade wing comprised of a frame, rectangular unit, gable roof and double door entrance with a gothic window above. An interesting house, it has been abandoned for some time. The limestone wall on the front facade has crumbled and fallen down. Condition of the house is poor and the farmstead has collapsed outbuildings.

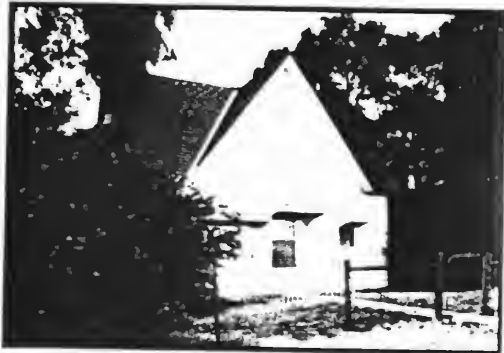
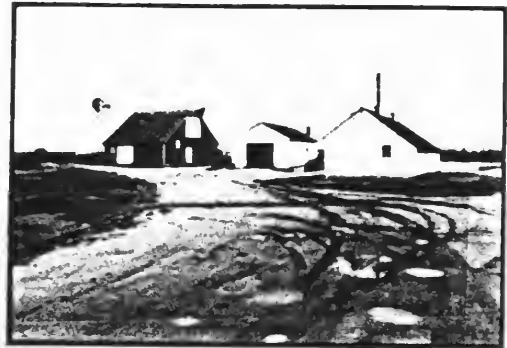
FROO-14

A large farmstead consisting of two frame barns with gable roofs, one frame shed with gable roof, one frame garage with gable roof, one frame cattle shed with shed roof and "T" shaped house. The house is one story, 1½ units, cross gable roof and latitudinal. Frame with wood shingled roof, centralized front door. Condition of the outbuildings and the house is very good and all are .. still in use.

- ⊞ Significant example of composite structures associated with cattle industry.
- ⊞ Architectural contribution of farmhouse to farm complex.
- ⊞ Integrity. Preserved condition of farm layout and cattle associated buildings.

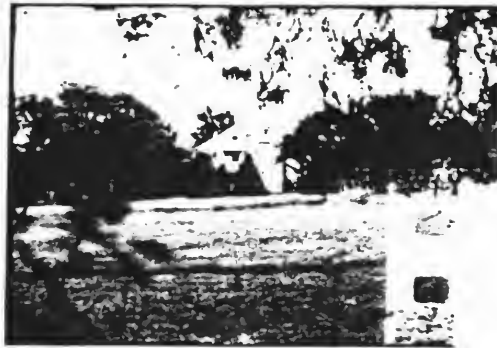
FROO-30

A large farmstead consisting of a group of frame outbuildings and a large farmhouse. The house can be described as a square, $1\frac{1}{2}$ units, two story with hipped roof. Extra feature include front gable wall dormer with second story balcony and an oval window in the attic section of the wall dormer. The house also has a centralized entry and wood shingles on the roof. The site is set back from the county road and is landscaped with cedars as well as deciduous trees. The house is still in use and is in good condition.

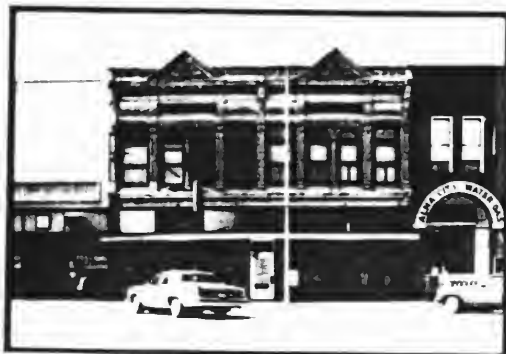
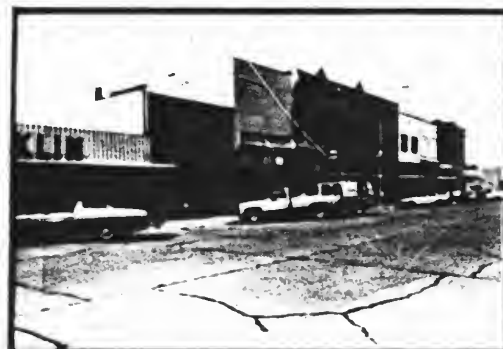
HNO1-101

The main characteristic lending significance to this structure is the survival of the cast-iron facade found on the upper story. This facade covers two commercial lots in what appears to have been a side by side business venture established by Frank and C.L. Myers. Although the lower story retains its original shape, most of the historic materials have been replaced. An A B A A B A rhythm has been placed on the facade with the B bays emphasized through semi-circular windows and a pedimented parapet. The remaining facade has been topped with a continuous bracketed cornice.

- ☐ Significant representative of commerce industry from period of historical importance.
- ☐ Architectural significance based on existence of cast-iron facade and upper level.
- ☐ Contextual significance. Retains integrity in enclave damaged by modern alterations.
- ☐ Individual integrity. 2 bays remain extant of original 3 bay structure.

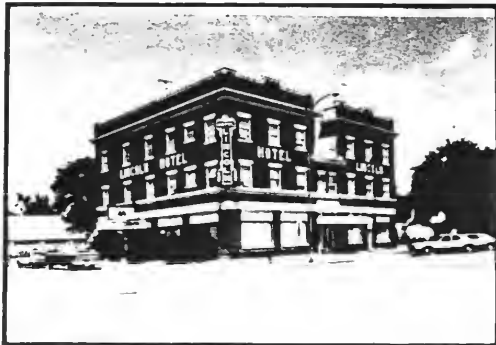
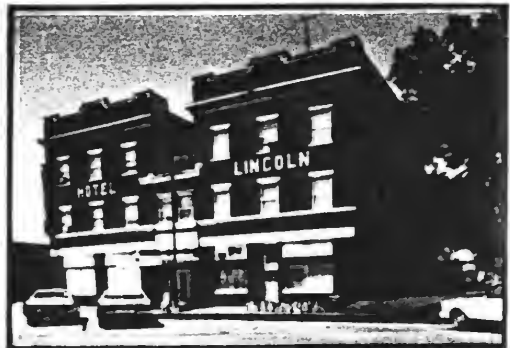
FRO3-55

The "Lincoln Hotel" is Franklin's oldest surviving hotel. Made out of dark brick, this three story hotel dominates the downtown commercial district. Features include; stone lintels, stone entablature with dentals and flat parapet roof. The "Lincoln" is based on a U-shaped plan. The U-shape allows for a large gabled skylight which provides outdoor light to the entry-way and open staircase. A restaurant is located on the first level with hotel rooms occupying second and third story levels. This hotel is still in use and is in good condition.

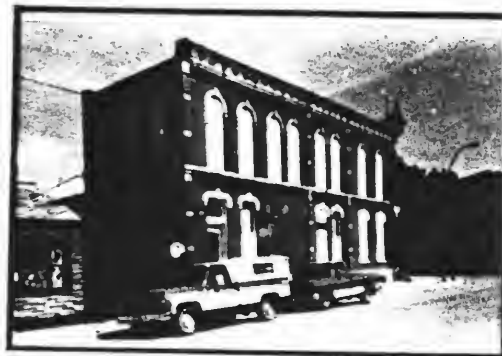
HN04-46

This two-story brick structure, built in 1885, recalls the typical bank form discussed earlier in HN01-97. As mentioned, the most consistent feature of this typology is the truncated corner which serves as the entry and main decorative element. A bracketed cast-iron cornice appears at both first and second story heights and is capped on the upper level by an elaborate cast-iron parapet. The structure is placed on a raised stone foundation which is pierced by segmental window openings. The first floor windows have been decorated with segmental hood mouldings, while the second floor openings are semi-circular in structural shape and have been finished with round hood mouldings. Additional decoration is seen in the polychromatic banding of the engaged pilasters and brick corbeling below the cornice.

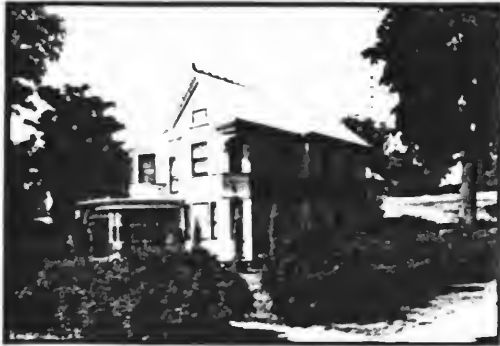
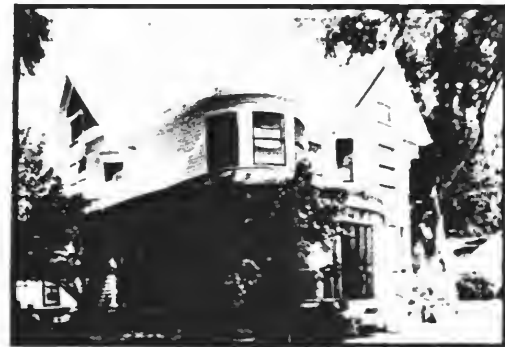
FRO3-34

Large Victorian house. Square shaped and two stories in height. It has a hipped roof and is placed in a longitudinal orientation. Decorative features include; two wall dormers, cut-out bays, corner turret with conical roof and cresting. The house also has a wrap-a-round porch that begins at the midpoint of the front facade and continues to the midpoint of the side. This house has a concrete block foundation, a band of fishscale shingling between the first and second story. Fishscales also occur in the attic wall dormers. The house is in good shape and it is still occupied.

- ☐ Constructed by prominent family active in commerce and culture within the community.
- ☐ Considered the most architecturally significant of Franklins "high style" residences.
- ☐ Architectural significance based on extensive use of stylistic details.

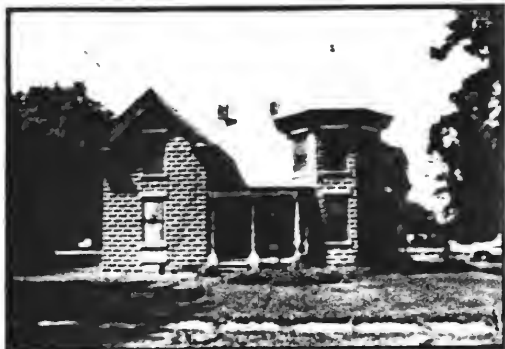
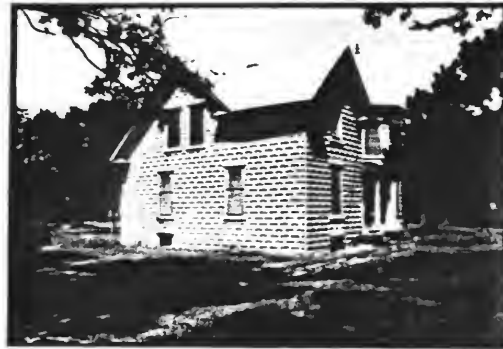
FR08-39

This is a unique example of a concrete block house. It is "L" shaped, $1\frac{1}{2}$ units, $1\frac{1}{2}$ stories with a gabled roof and orientation of the house is longitudinal. The front porch consists of three concrete columns. Stone lintels occur over the windows and an octagonal second story tower is placed on one of the front facade corners. Windows are placed on each of the eight sides and each of the two stories of this tower. The tower roof is also hipped. This site is in fair to poor condition and is occupied.

- ☐ Important resource in relation to the limited architectural context
- ☐ Sophisticated use of a comparatively uncommon and non-flexible material.
- ☐ Unique example of High Style as applied to masonry construction
- ☐ Although showing signs of deterioration, the house remains unaltered including an original concrete porch.
